Manhole Inspection Summary

Manhole # S13KK1023MH

Insp Date: **12/14/06 2:04 PM**

Location Address: **4630 PALL MALL RD**

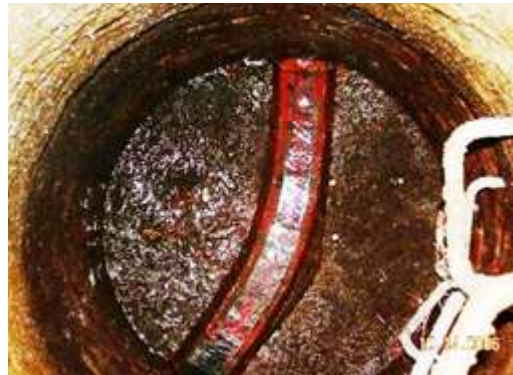
Top View

Evidence of surcharge - Bench debris.
Corroded steps.

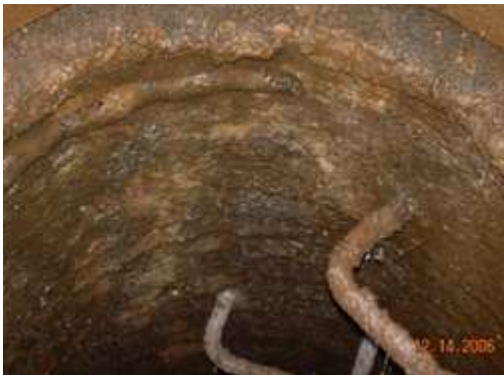
Defect

Frame leaks. Frame offset. Adjustment
infiltration.

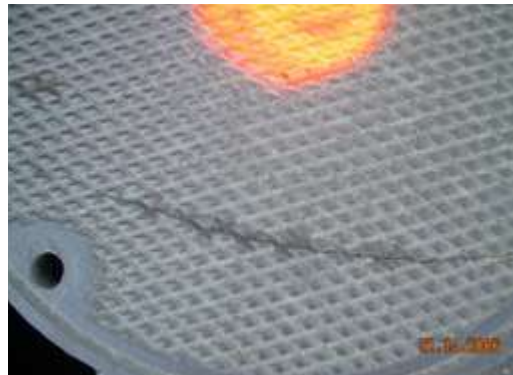
Defect

Cracked lid.

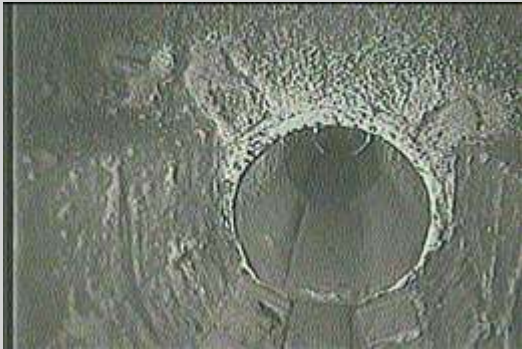
8 in. Circular Gravity Sewer Pipe Out @ 12 O'Clock

Infiltration: **None** Pipe Seal Cond: **Cracked**

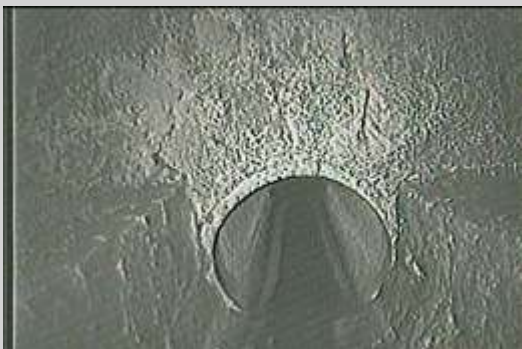
8 in. Circular Gravity Sewer Pipe In @ 7 O'Clock

Deposits: ☐ None ☐ Mud ☐ Sludge ☐ Debris ☒ Grease

Silt Depth: **0** (in.) Deposits Extent: **Light**
